Docket No. 217 – Development and Management Plan Inspection

Northeast Utilities Service Company Certificate of Environmental Compatibility and Public Need for the construction of a 345-kV electric transmission line and reconstruction of an existing 115-kV electric transmission line between Connecticut Light and Power Company's Plumtree Substation in Bethel, through the towns of Redding, Weston, and Wilton, and to the Norwalk Substation in Norwalk, Connecticut.

Date: September 21, 2005

Location: Overhead Line (Composite 345kV and 115kV Gallows Hill to Archers Lane)

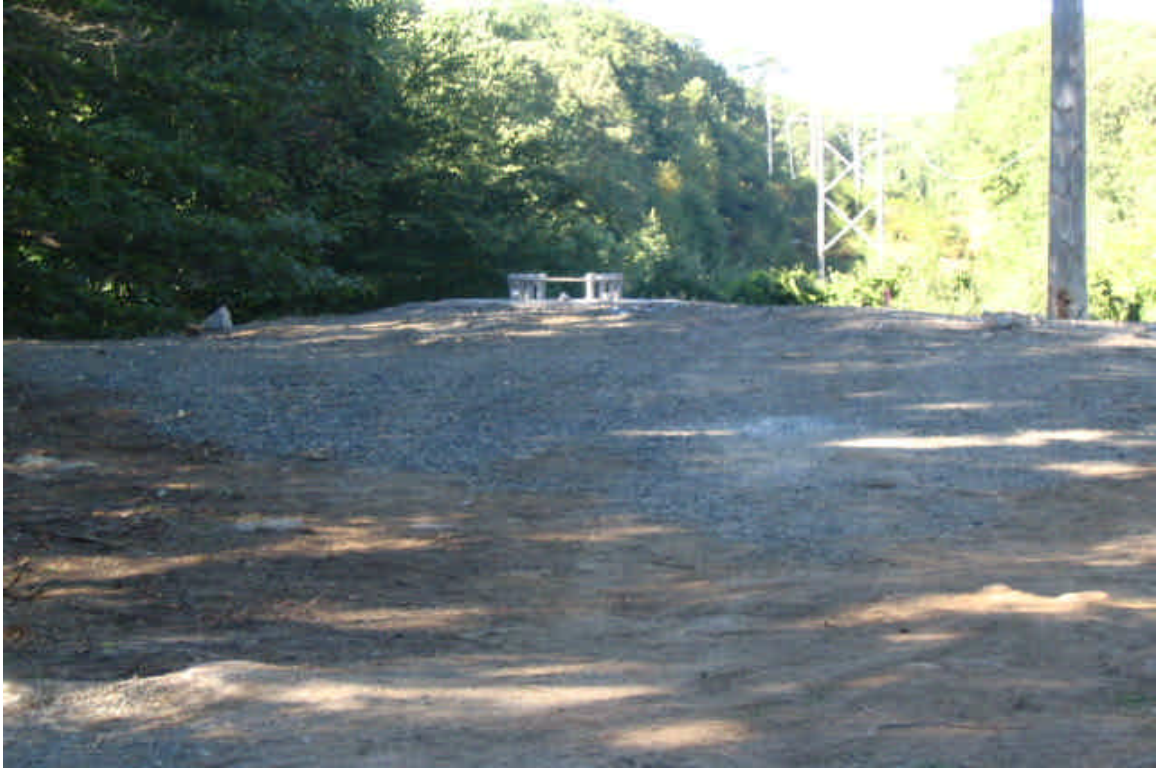
Overhead ROW: View of the caisson foundation for the riser structure installed at the intersection with Gallows Hill Rd. (9/21/05)

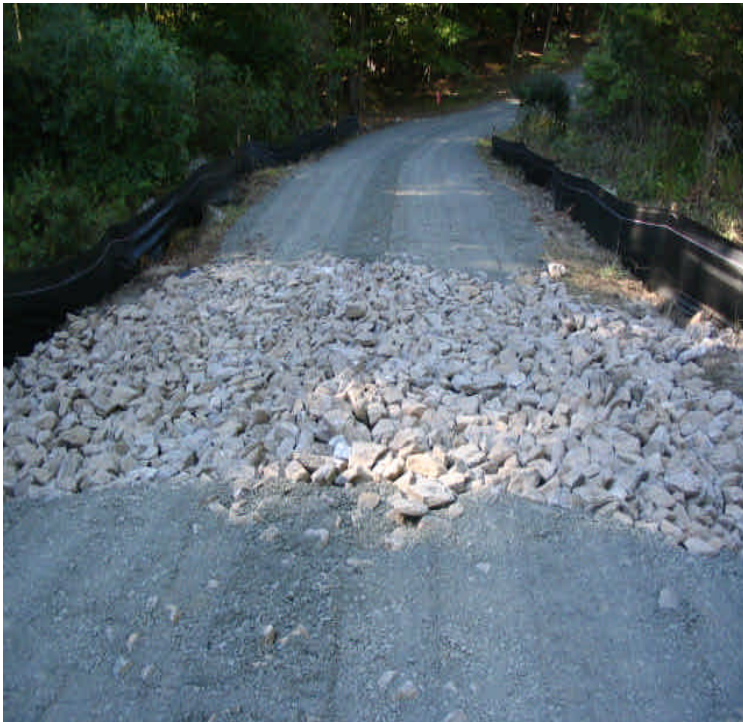
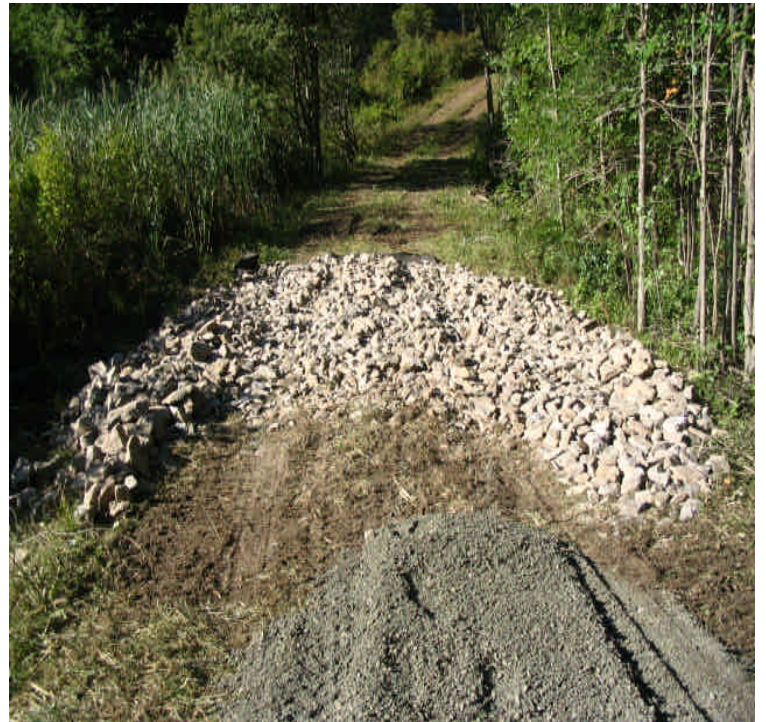
Several low wetland areas along the existing access path in the ROW were placed with geotextile fabric and stone to prevent damage to the wetland crossing. Other portions of the path were placed with stone dust. (9/21/05)

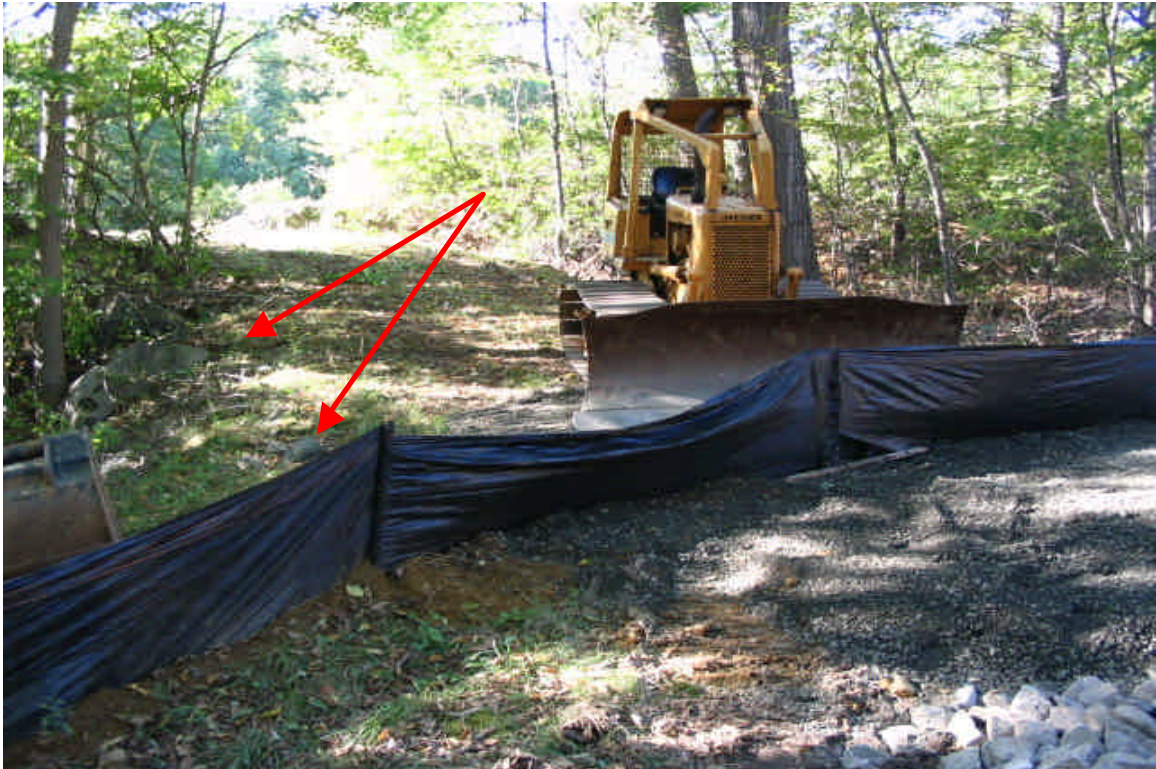
View of where the access path to the ROW intersects with the Archers Lane transition station site. The silt fence will be replaced with haybales to allow access and will be the jurisdiction of the overhead work. It is recommended that the silt fence be extended along the path. (9/21/05)

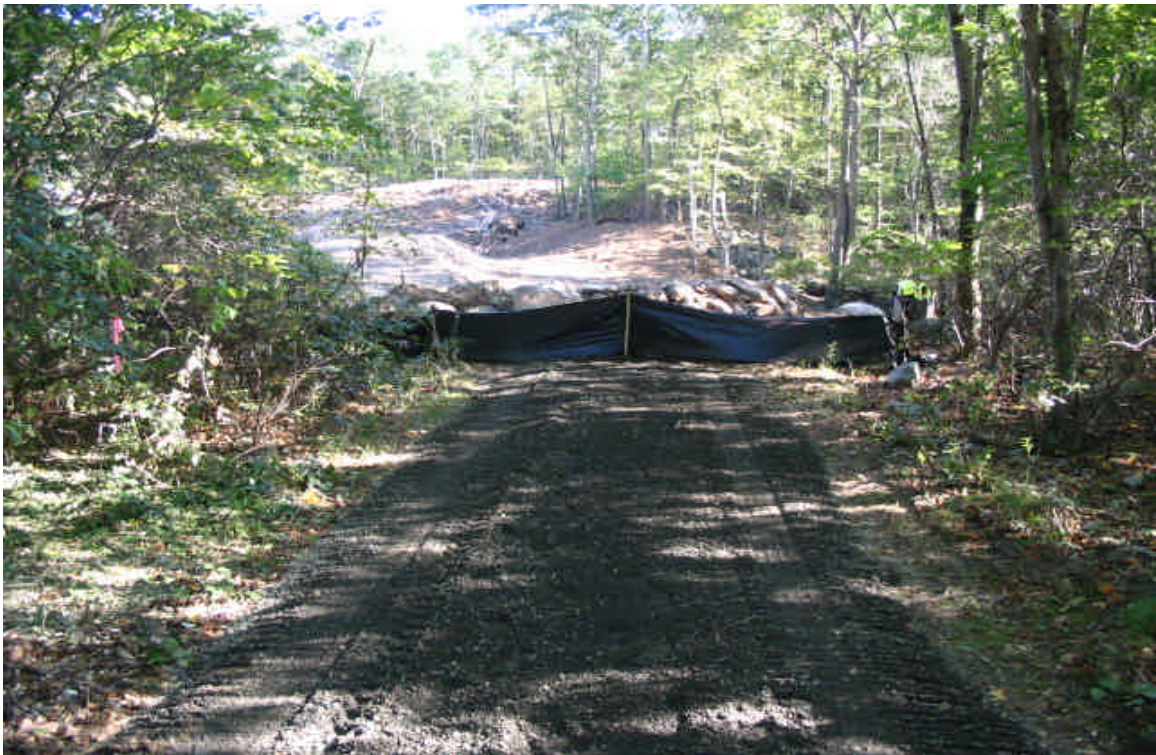
Another point where the access path leads into the Archers Lane site. Haybales will also be installed here in place of the silt fence to provide access. (9/21/05)
